**SITE SUMMARY REPORT**  
**NCDOT Project K-3807**  
**I73/74 and US 220 Bypass Northbound Rest Area**  
**Randolph County**

Hurricane Recovery Act of 2005  
State of North Carolina  
State Contract N06009S  
Schnabel Project No. 06210002.1C

December 3, 2007

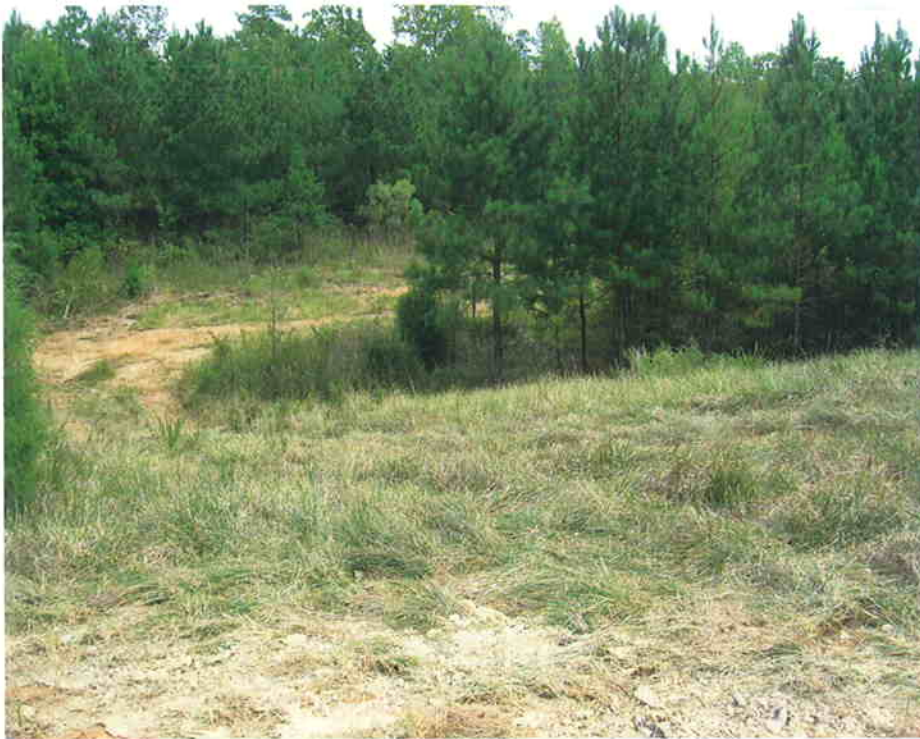
**PHOTOGRAPH No.: 1**

Photo taken facing toward the southeast. The slope is the southeastern perimeter of the Disposal Area.

Access to the Disposal Area is from a dirt road off of Business 220 (Photo 1). The Disposal Area occupies 4.8 acres based on the Disposal Area perimeter shown on Figures 1 through 3.

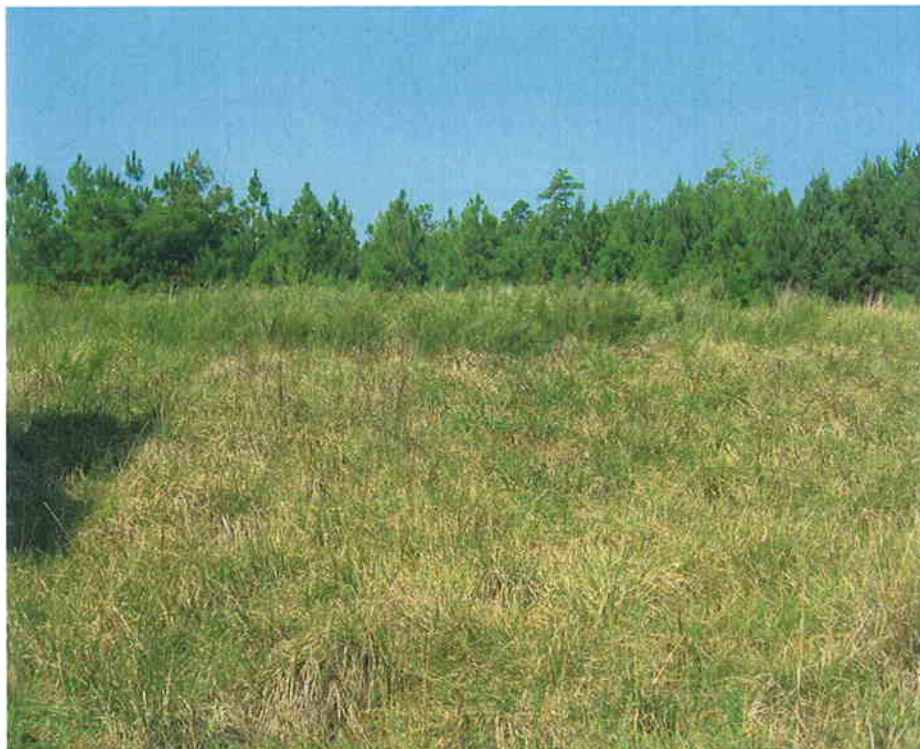
**PHOTOGRAPH No.: 2**

Disposal Area is mounded up and covered with tall grass and pine trees of three to five inches in diameter. Photo taken facing toward the west.

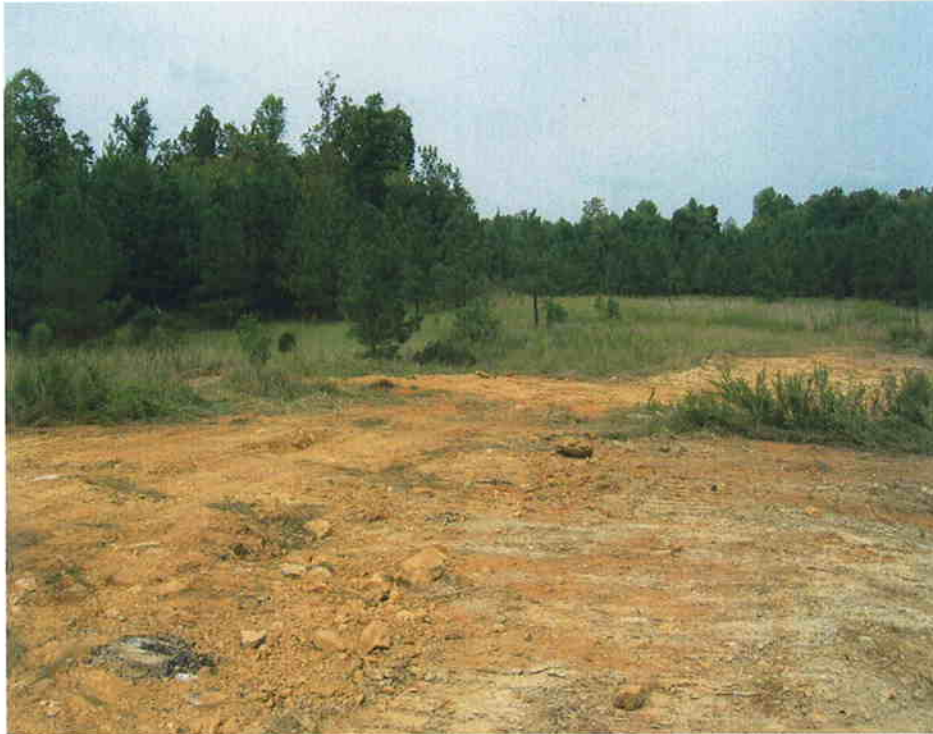
**PHOTOGRAPH No.: 3**

Photo taken facing toward the east. Sloped area is eastern perimeter of Disposal Area. Bare soil from September 2007 NCDOT subsurface investigation.

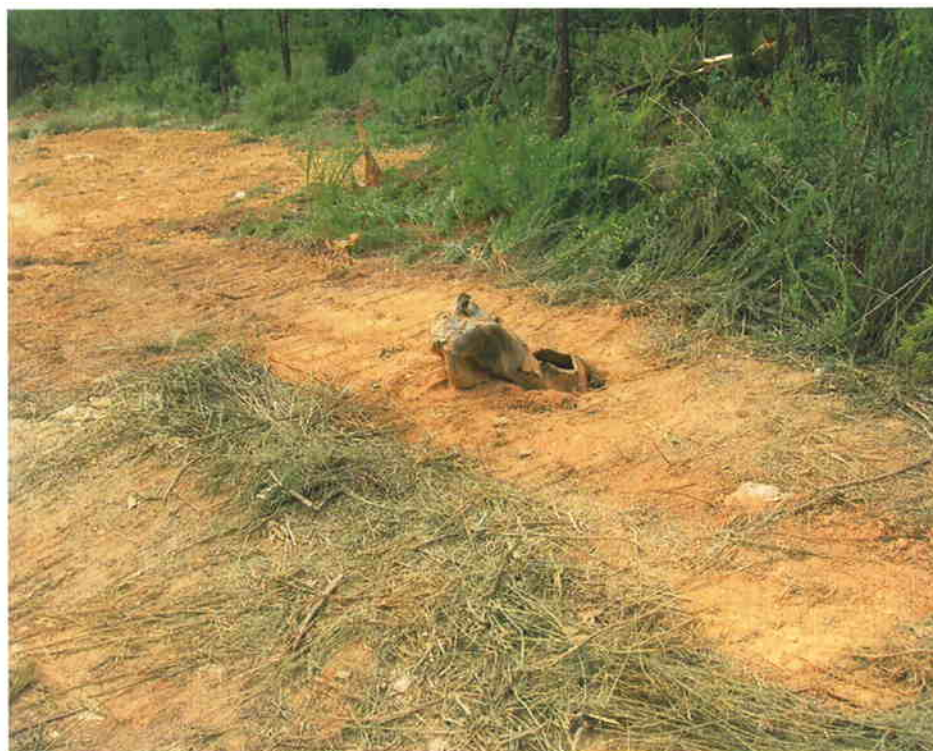
**PHOTOGRAPH No.: 4**

Exposed tire. Bare soil from September 2007 NCDOT subsurface investigation.

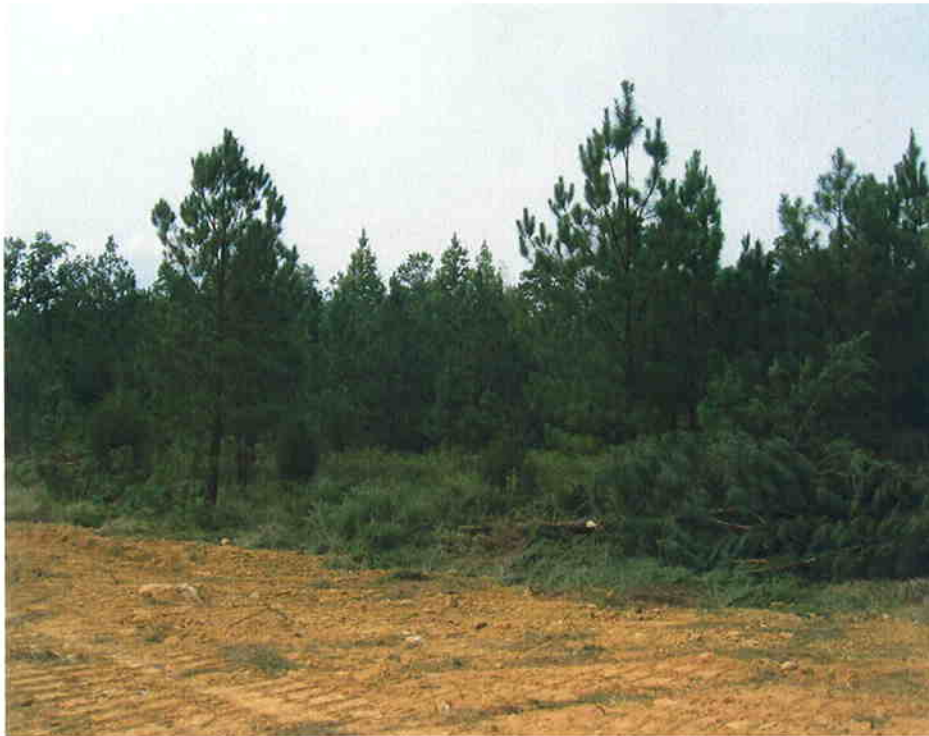
**PHOTOGRAPH No.: 5**

Photo taken facing toward the northwest. Bare soil from September 2007 NCDOT subsurface investigation.

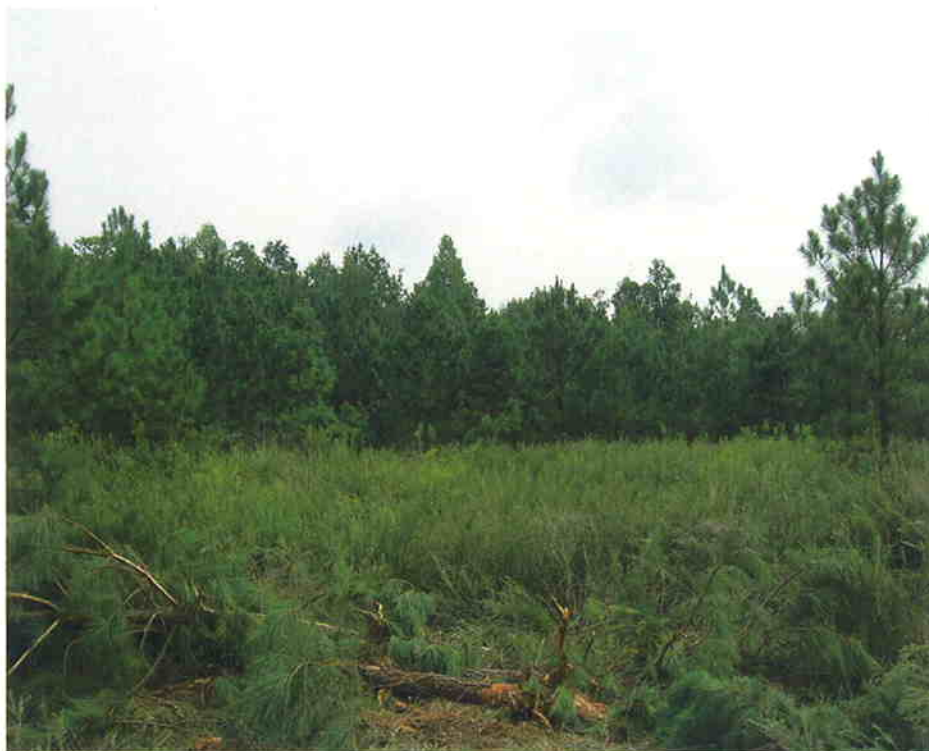
**PHOTOGRAPH No.: 6**

Photo taken facing toward the north. Dense vegetation. Trees represent northern Disposal Area perimeter.

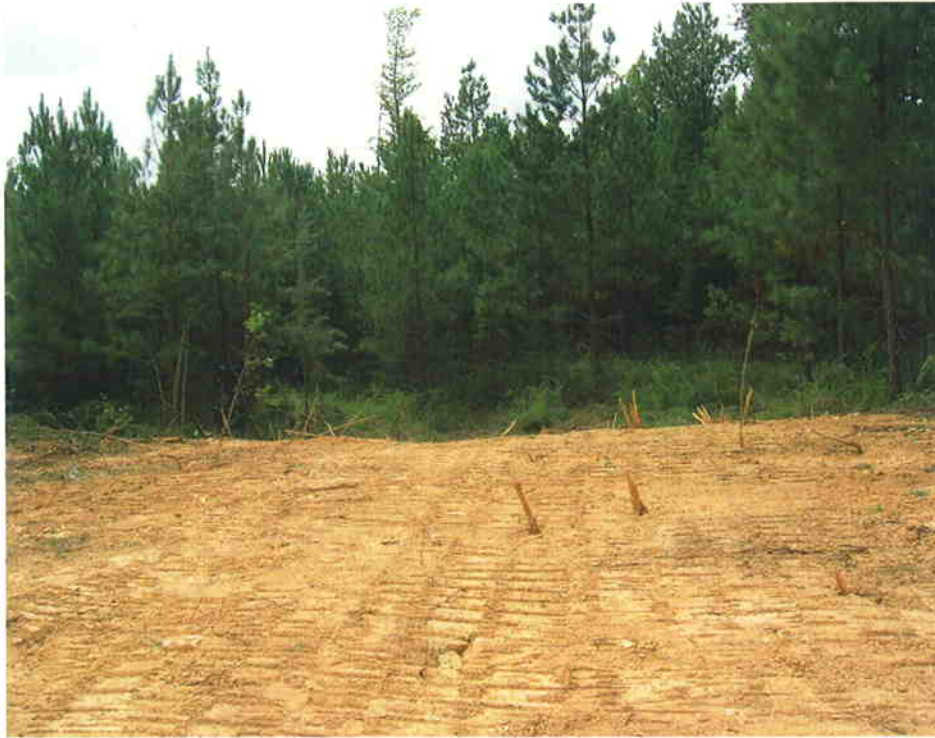
**PHOTOGRAPH No.: 7**

Photo taken facing toward the west. Bare soil from September 2007 NCDOT subsurface investigation.

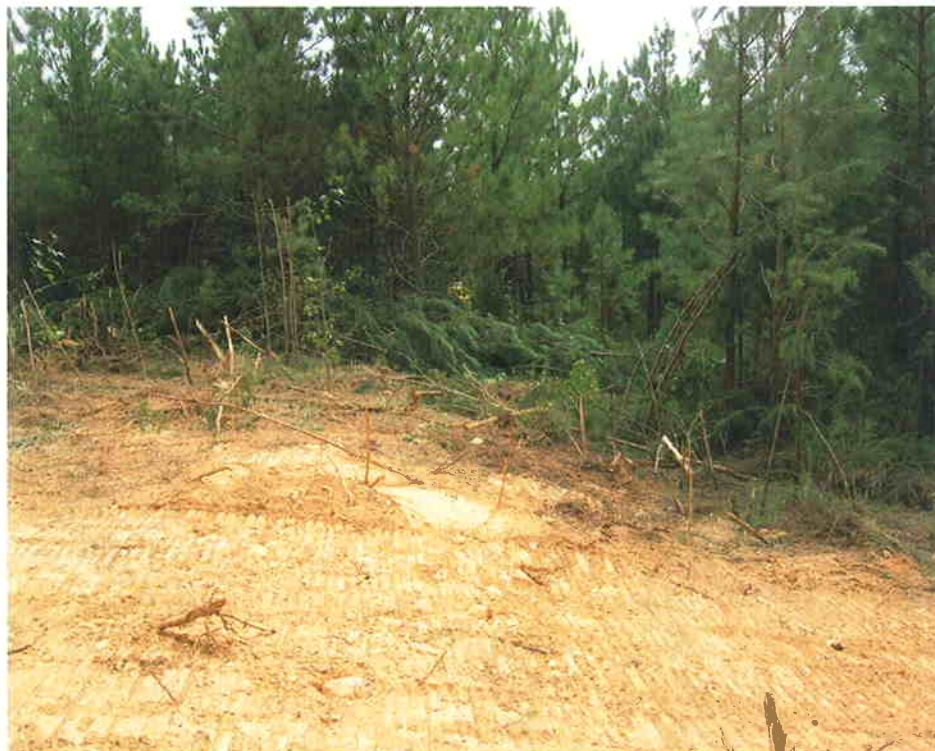
**PHOTOGRAPH No.: 8**

Photo taken facing toward the south. Bare soil from September 2007 NCDOT subsurface investigation.

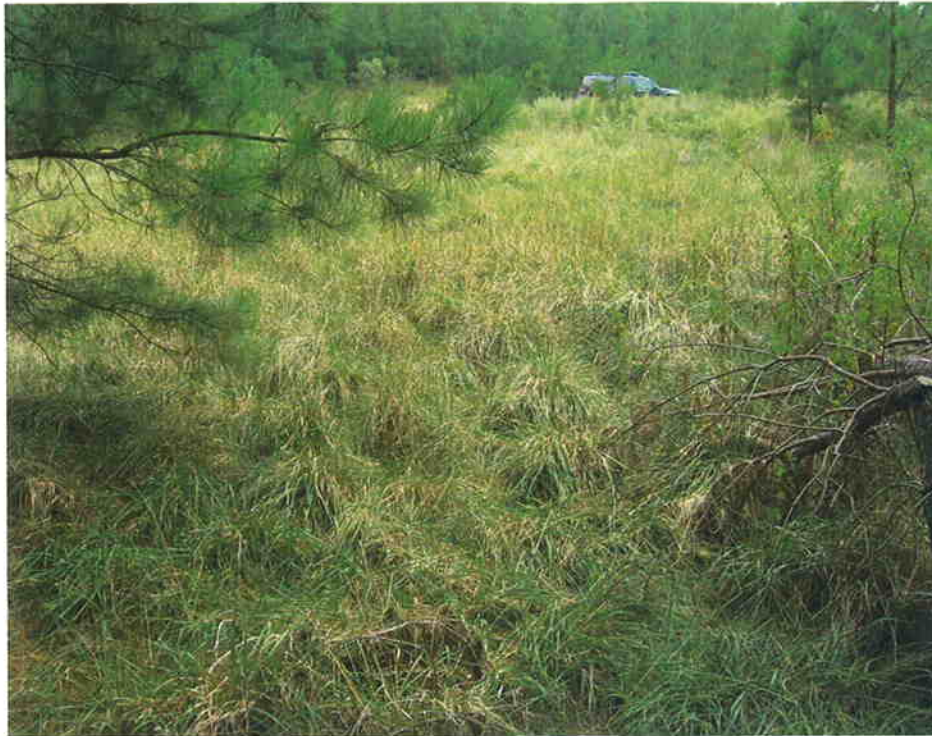
**PHOTOGRAPH No.; 9**

Photo taken facing toward the northeast.

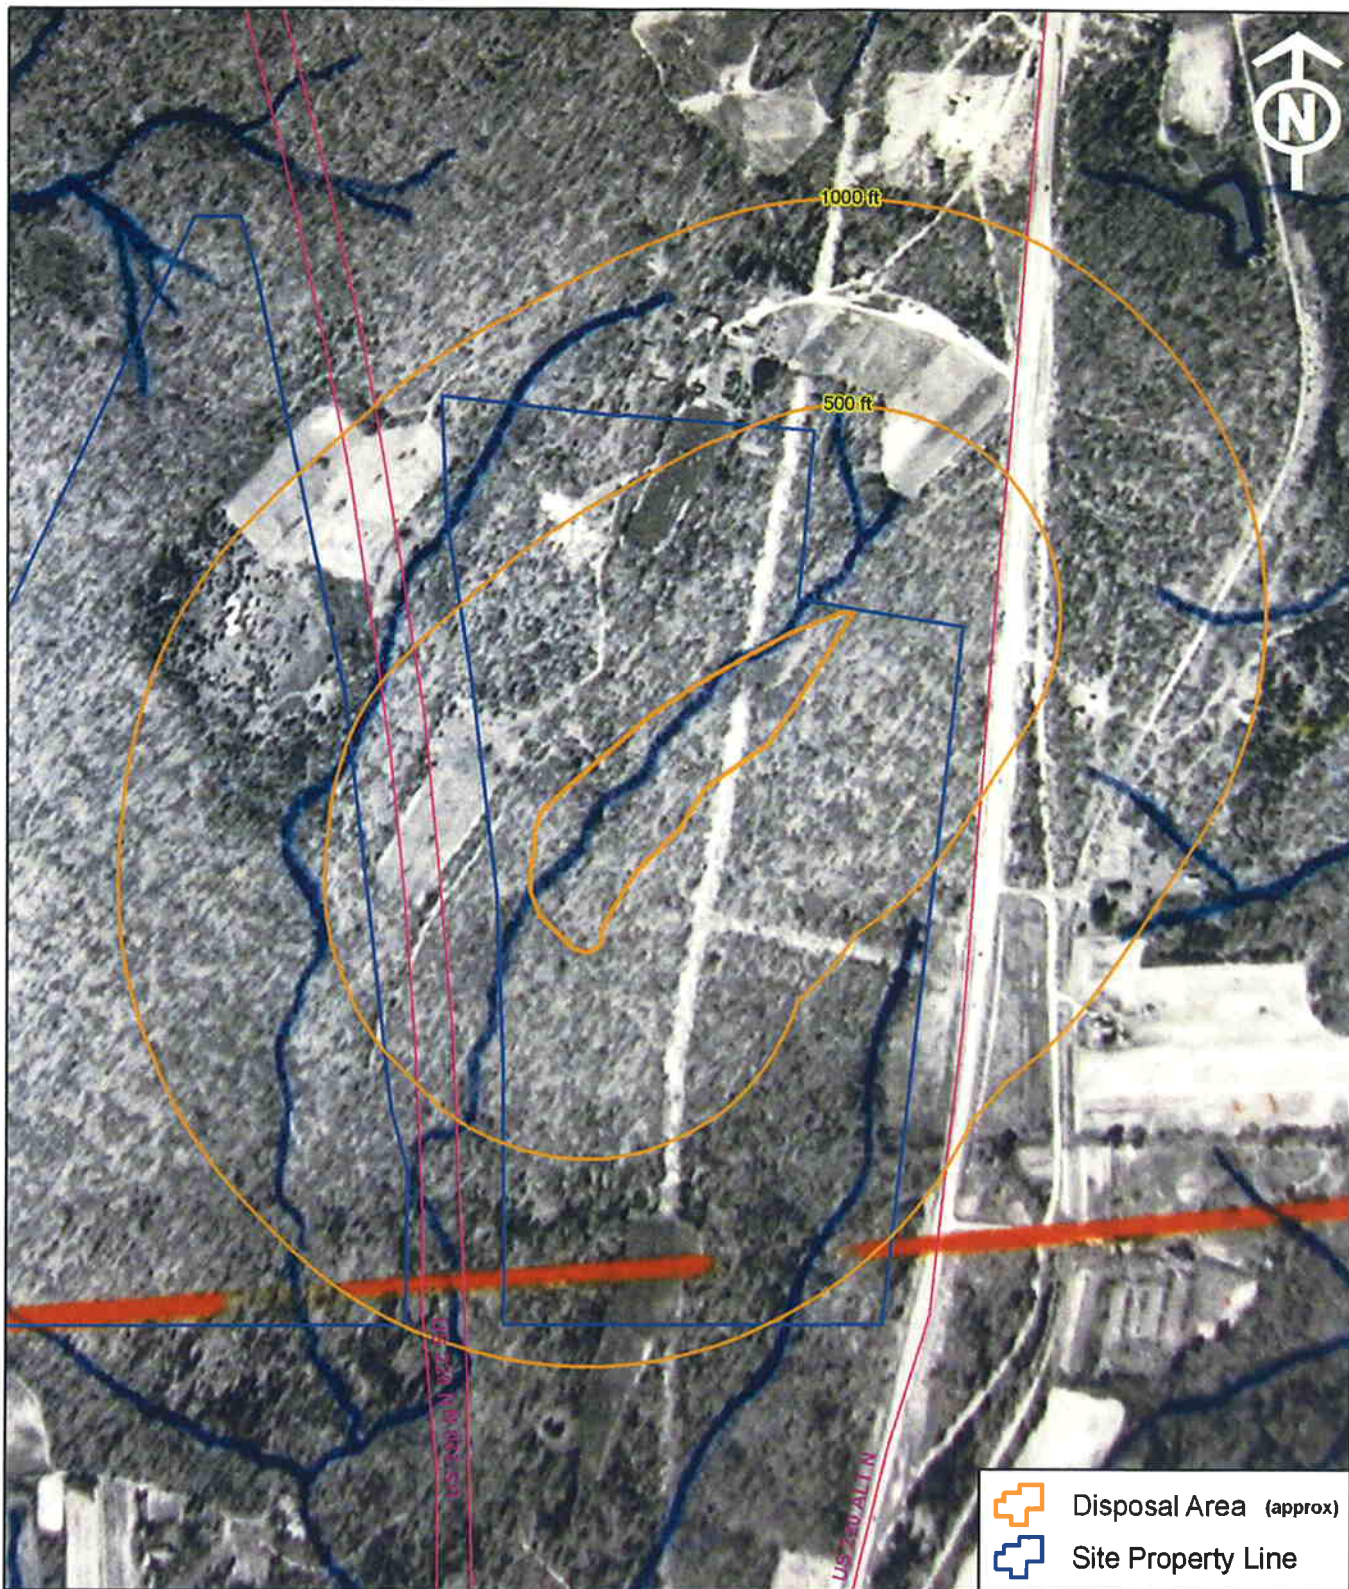
Figure E-2

AERIAL PHOTO OF SITE  
1957
